Condition Assessment:

TechWorks!
Central Block
Renovation

321 Water Street Binghamton, NY

10-12-2018

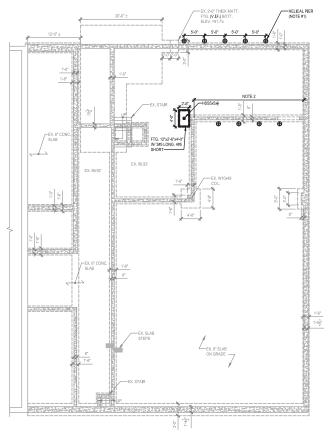
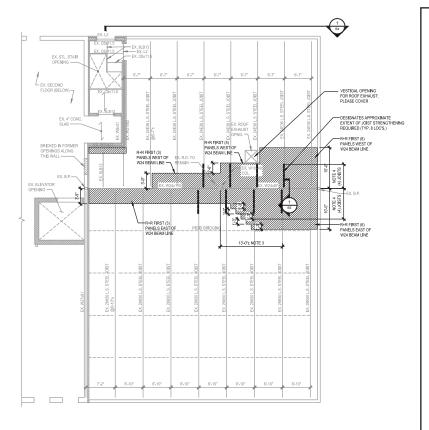
Significant settlement cracks in west exterior wall of Central Block, built 1946. Failed waterproof roof membrane damaged concrete roof panels and supporting structure that requires remedial structural work.

Restore the integrity of the existing roof and prepare for future installation of an amenity space on the roof, Riverview Terrace.

Install pilings to prevent additional settlement cracking of brick wall and to provide support for future roof terrace.

Extent of repair to steel roof structure to be determined when existing roof removed.

Replace existing roof membrane in its entirety. Two options for new roof deck involve either

- a) replace the damaged section of existing concrete roof deck or
- b) replace roof deck with more modern, steel roofing system.
